Collapse of seawall at Sluice No. 2 - South Woodham Ferrers

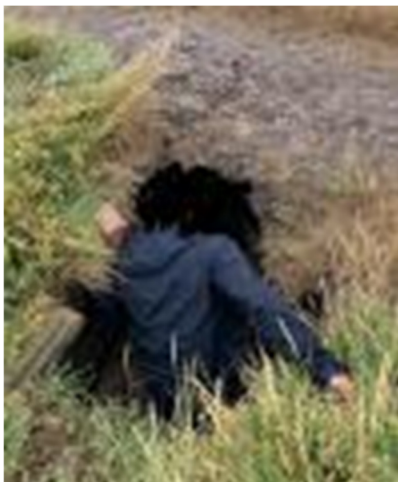
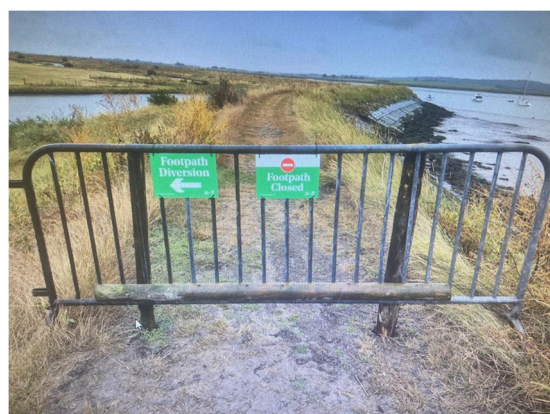
- It has since been determined that Sluice No 2 is not maintained by the Environment Agency and has not for approximately over a year.
- The sluice has been defective since at least 2018 and the Environment Agency have chosen not to repair the sluice and consequently removed the flap valve from the sluice. It is not clear whether this decision was consulted upon or made public.
- The deterioration of the sluice has caused erosion around the sluice pipe resulting in a cavity undermining the sea wall and ultimately in this large hole appearing.

Below are photos of the hole itself with a person inside to show the size and the barrier preventing access.
